The following article was published in the Jaguar Driver magazine, September 2016, and is reproduced here with kind permission from the author, ALAN HAMES, C.Eng., MICE, MCIHT
 Alan is a multiple concours winner in UK, with his 1972 E Type V12, which he has owned from new.

Stromberg carbureted V12's Hazardous Petrol Leaks in Engine Compartment

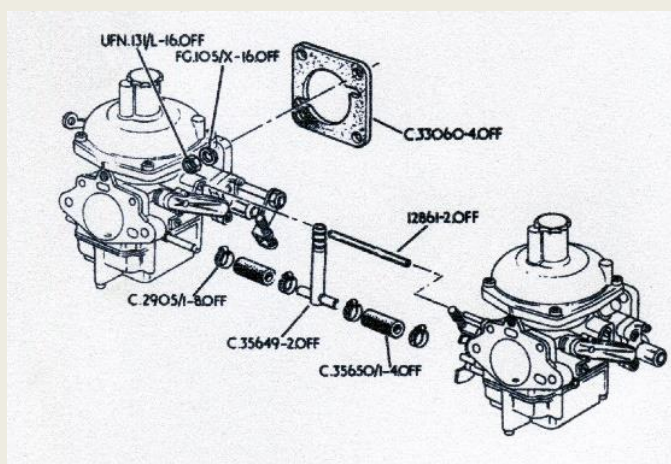
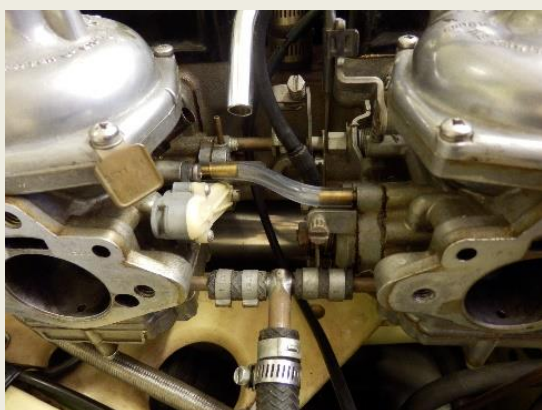
As those of us who are mechanically minded and have a basic knowledge of the carburetor operating system, we will be aware that there is a somewhat unexplained small bore clear, (or green), plastic tube linkage between the carburetors on both the nearside and offside twin carbs. This does not have any obvious function and when the bonnet is lifted when cold, or when the engine is at operating temperature, this tube does not seem to have any fuel visibly passing through. However, it has an important job to do when starting the car from cold and when operation of the choke is necessary, as this allows fuel to pass through to enrich the mixture.

A close inspection of these short and inaccessible tubes, that over the years are likely by now to be well discoloured brown from the passage of fuel for so many years, makes any assessment from above very difficult. In my case this was the situation and the arising split in the tube could not be seen and could have been the cause of a fire, fueled by streams of petrol on both sides. When the tubes are removed it is clear that the sharp bends at each end, where they locate over the carburetor brass tube stubs causes them to fracture at this point which cannot be seen.

Manual turned up their original Part Number 12861. However, as expected, this cannot be obtained from Jaguar, as this is now a superseded part. In my case, with my store of so many hoarded parts I was able to replace one with an old original Jaguar part, but the other one required some web searching for tubing suppliers and the purchase of a suitable length, so I am pleased to say that my problems have been solved. Anyone else needing the part I am sure will find that this can be sourced from various of the Jaguar Parts suppliers, but be careful to ensure that whatever is on offer is a tube that is petrol resistant, as some plastics are not suitable and may even be too flexible and not heat resistant enough for this location.

As I said above, take note of the warning and carry out a check on your car, (and the other small rubber connecting tubes in this area), as I am sure that many V12 owners will be unaware that there is a problem in waiting that could be not only costly, but with petrol in mind also life threatening. Hopefully a simple check carried out before the next trip will avoid a potential disaster to one of our treasured cars.
