Battling on with my 1965 4.2 Mark 10 (Caspian)

Sunday, 21st June 2015

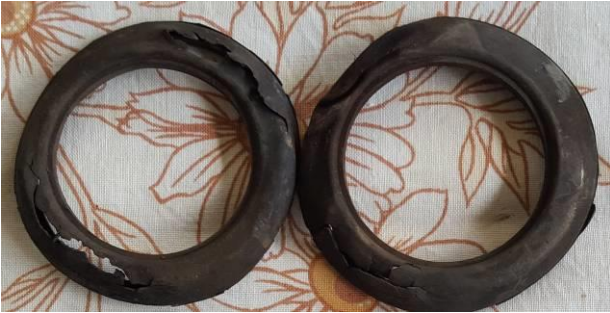
*Yes, this is what the old calliper dustboots looked like,
No wonder the pistons were u/s.
I sourced a new genuine calliper kit from USA, through
Ebay.*

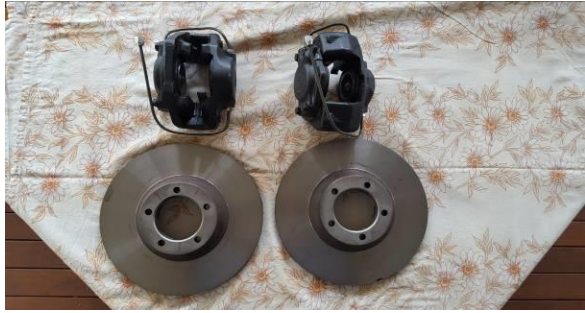
*Good as new, and ready (nearly) for action!
Great job Greg. Thanks to you and all at Brakeforce.*

One brake rotor had a small chip on the circumference which made me suspicious that it might cause a roadworthy failure, so I took both of them to David Dimmock, who said he "probably" would pass them. In the hope that I can rely on his "probably", I've sent the front rotors and callipers off to Brakeforce, and they've come back shiny and new-looking. At last I can re-assemble something!!

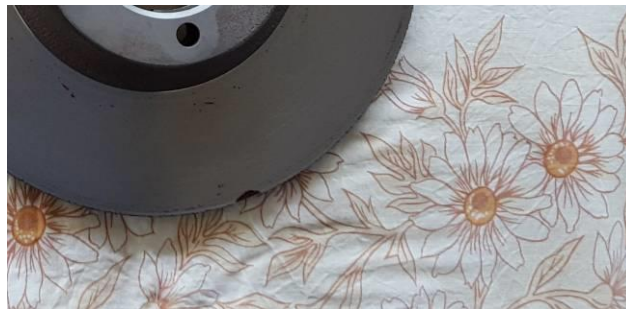
And here's the offending chip on the edge of the rotor, which appears on the reverse face as well.

The rotors have now been re-fitted, and the bearings re-packed. The rotors were skimmed down from 12.7mm to around 12.3mm - well over the minimum of 11.5mm - but re-fitting the callipers is a continuing challenge. I couldn't find my set of feeler-gauges anywhere, so I had to go out and buy another. I hadn't kept the old shims in any kind of order because I knew the brakes would have to be re-set, but I didn't realise how difficult it would be to manipulate these shims in to place - and every time I re-calibrate the clearances and calculate the required shim adjustment to centralise, the new unequal clearances seem to defy logic. Trial and error will no doubt get things right in the end, but what a pain!!
