Part 6

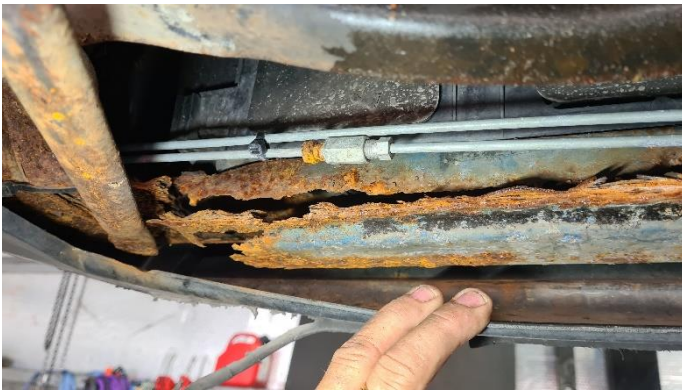
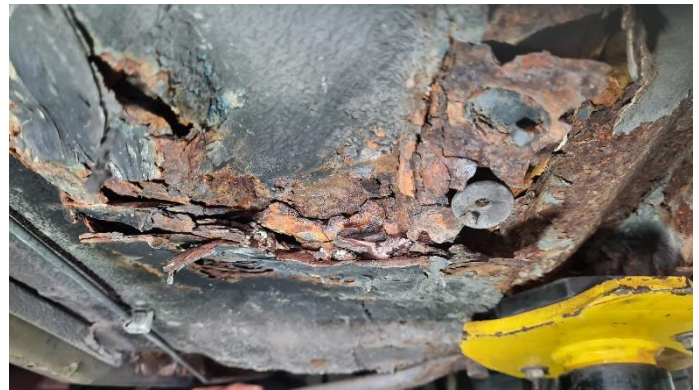
I was lucky enough to source a spares car around this time – a 2000 XK8 Convertible. But one person's good fortune is always another person's bad one, and the unfortunates in this case were fellow members Dave & Sarah-Jane from Cairns, whose car turned out to be too far gone – mainly rust – to be salvageable economically. But there are plenty of hard-to-get parts that I can use on my car, and maybe I can get to sell some others.

The dreaded tin worm strikes again!

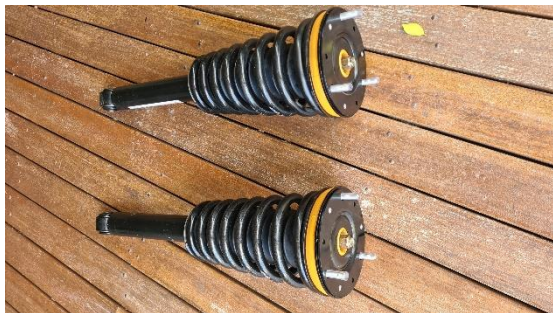
My front shock absorber bushings were on their way out, so I sourced the upper bushes from Jagdaim in Melbourne, and bump stops and dust boots from Pedders in Townsville. Removal and replacement of the coil-over shocks is quite straightforward, and I could have struggled with my spring compressors at home to fit the new parts, but it's so much easier with a suitable hydraulic press, so off they went to Chris for his attention.

On the right - Chris, the coil-over shock unit, hydraulic press, and a safe pair of hands ...

On the left, the finished articles ready to be fitted back to the car.
