Introducing Prince Caspian

Monday, 11th May 2015

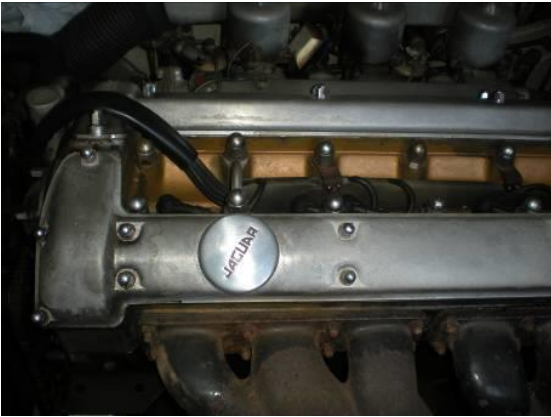
I have to restrain myself! I get carried away cleaning and scraping etc, when I should be focused on more important matters. But hey!, I've polished the important bit – the oil-filler cap.....

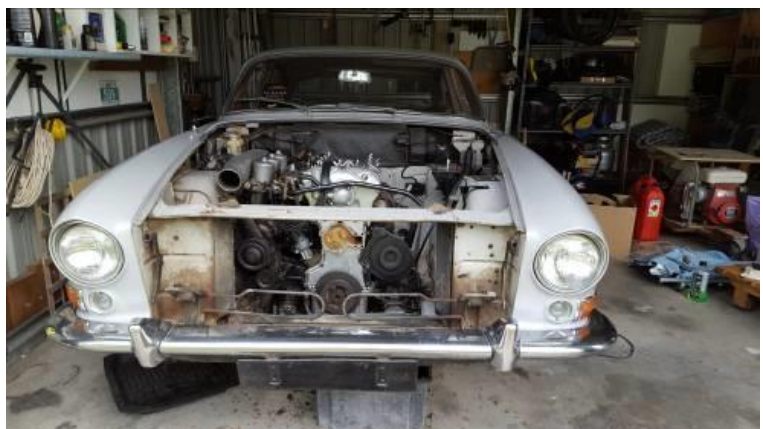
- As noted before, the paintwork is original, but badly oxidised. I've used a cutting compound on most of the panels to see how this would improve it. Seems to be much better, though not by any means where I want it to be. I'll continue with the compound and polish, but I suspect eventually I'll get the car professionally resprayed. Another job for the future.

*The poor young man as he is today –
at least some of the dirt has been removed!*
