Monday, 23rd November 2015

**Heater**

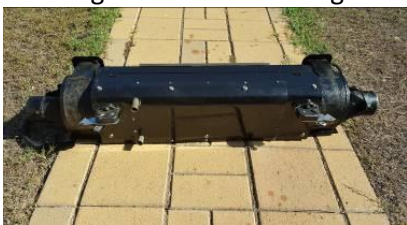
The heater box has now been rebuilt and re-fitted to the bulkhead, after some serious cleaning! The insulating covers look their age and may need replacing soon, but where do you stop?

*The finished heater box ready for re-fitting.*

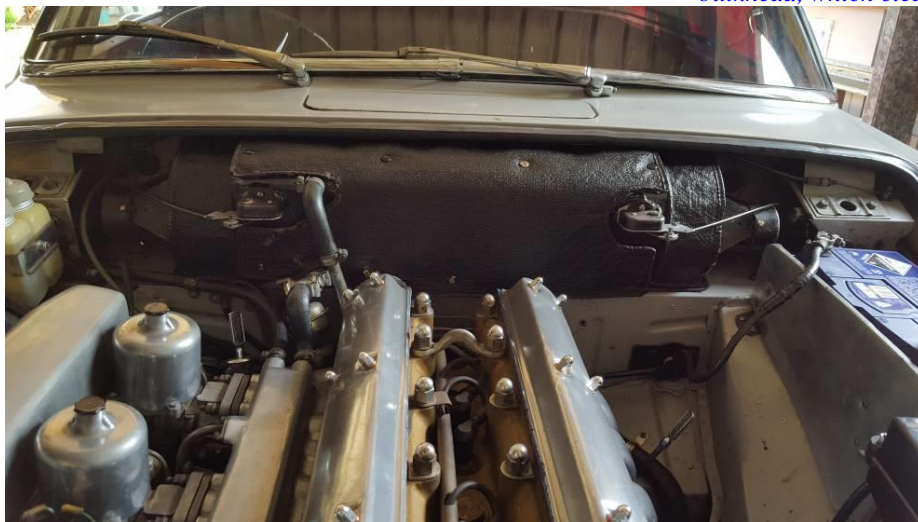
*The finished heater assembly - waiting for the first snows in Townsville.....*

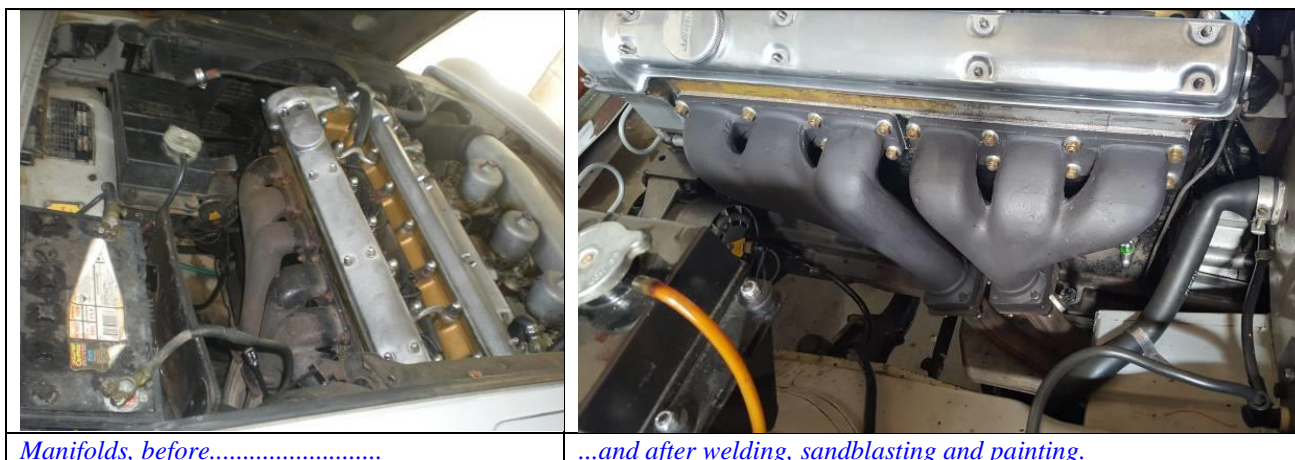
Nothing much to report, except cleaning and polishing.

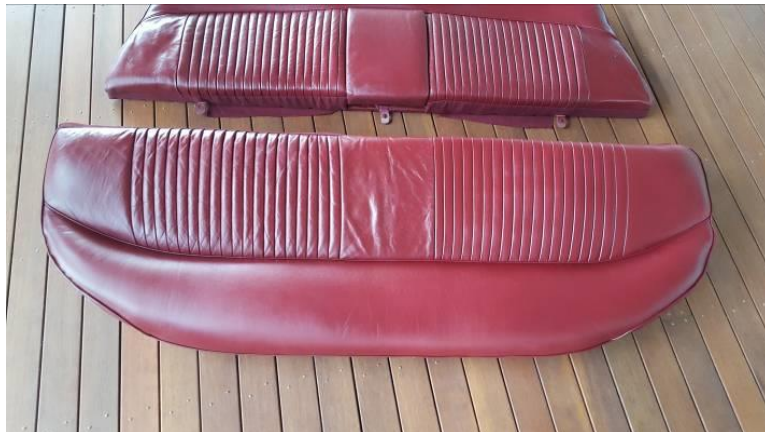
The rear seats have now been finished, and look spectacular. They do not look "brand new" as they retain a delightful patina of age.

*The back seats have been repaired "sensitively". "Caspian" should not masquerade as a new car, but rather will gracefully show his age.*

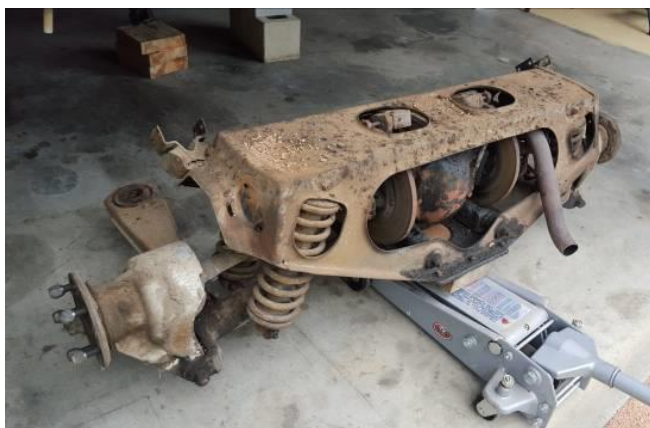
The IRS sub-frame has been removed, but not without some drama. The exhaust system has been welded together rather than using clamps, so separating it required some cutting.

The whole IRS unit is very dirty, and will require severe cleaning and dismantling before any rebuilding can take place.

*Jaguar allowed 45 minutes for removal of the IRS sub-frame. It took me the better part of 2 days to get to this stage!!!  
The unit is very heavy, and manoeuvring it around the limited space in my shed is a challenge.*

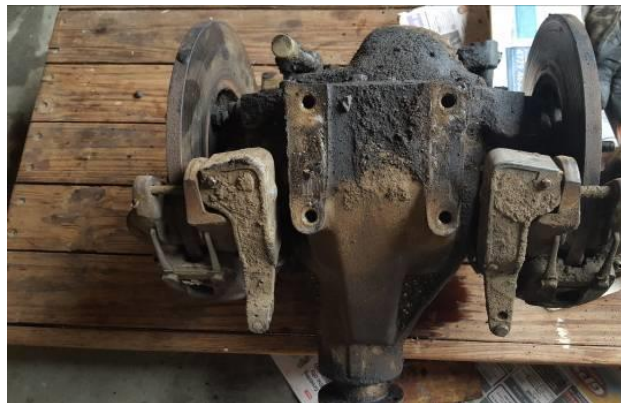
*The brake calipers and rotors have been removed and sent out to Brakeforce for reconditioning.*
