Part 9

Engine Fault

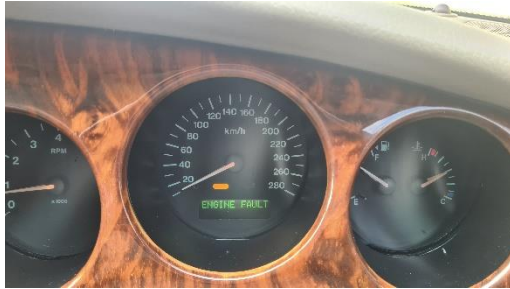
In March, on my way to join up at Caltex Yabulu for the very successful Hinchinbrook High Tea Prowl, I got an amber “engine fault” error message on my dashboard. I immediately pulled into the side of the road to take stock, even though there had been no change to engine sound or performance, but couldn’t see/find anything obvious, and on re-starting the engine, everything was normal again. A temporary glitch? No such luck! After another couple of kms the message re-appeared. I stopped again, re-started, and finally arrived safely at Yabulu – but wasn’t going to risk a longer trip, so got a lift to Hinchinbrook and back. Later that day I got home safely, and the following morning ran a comprehensive scan for error codes to try to identify the underlying problem.

The initial scan came up with a staggering array of fault codes – too many to be useful, so I cleared the codes I could, leaving 3 remaining codes. I then took the car for a drive, came back and tested again. We’re now down to 5 codes, including “battery supply fault”, “brake switch faulty”, “CAN bus fault”, “SCM fault” and “CCM fault”.

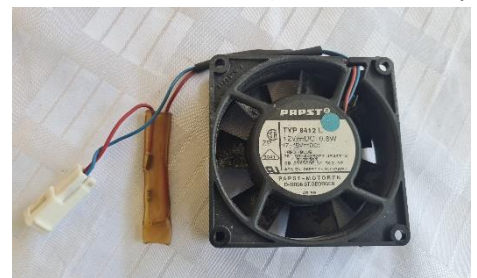
The “CAN bus” fault became my primary focus. This type of error typically indicates a fault in communication between the various control modules in the car, of which there are many, and can initiate other fault codes (such as “battery supply fault”) simply through lack of good signals. I removed the Transmission and Engine Control Modules to run some contact cleaner over the plugs and sockets, only to find that the coolant fan under the ECM wasn’t working. These fans are generic so I bought one from a computer store. Now the area is adequately cooled – but the problem persists. I cleaned the contacts for other control modules I could easily access, but without any joy. As testing the connectors is beyond my abilities, it’s now time to bring in the professionals!

I spoke to my neighbour Matt (Mark Nixon Automotive) and the car was booked in for diagnosis. All module connectors were cleaned and tested. The fault persisted, albeit only now when engaging cruise control and the main suspect was the brake/cruise control switch. Brake lights work normally, but the cruise control system needs to know the brakes are not being used in order to activate, and to de-activate when the brake pedal is depressed – and it seems it’s not getting a consistent signal.

Luckily, I have a spare brake switch, bench-tested and fully functional – I just need to schedule the time to fit it (it’s a fiddly job). The good news is the “engine fault” message has not returned, even after about 1500kms. Remember not to engage cruise control, at least for now. Phew!

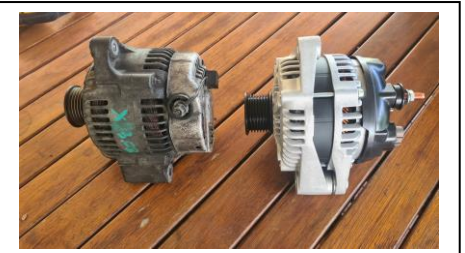
While my car was off the road with its engine fault, I decided to investigate the alternator, which I had been unhappy with for some months. It appeared to be working adequately, but was noisy. When I bought the car, one of the first things I fitted was the plastic alternator cooling conduits, which were “missing”. I suspected the alternator had been running too hot for some time, and that appeared to be the case. I sourced a replacement alternator – and not a moment too soon! The day I chose to fit the new alternator, I started up the car – and it wasn’t charging!! I checked the external wiring as best I could, but everything appeared fine. The offending alternator soon came out. I had to replace the alternator plug on the wiring loom – I found

The old alternator was obviously not original. It's marked X308

👉 a new one here in Townsville for around \$8. The new alternator was duly fitted, is noiseless, and charging perfectly.

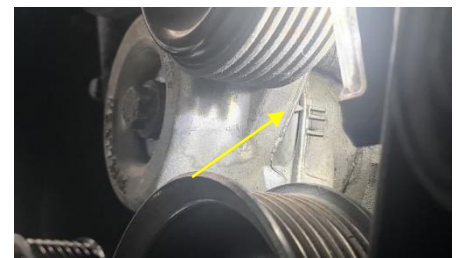
I had intended to replace the serpentine belt while changing the alternator – just as a precaution. Before I did anything though, I had a good look at the front of the engine, and came across these markings on the belt tensioner. I looked it up in my workshop manual, and, surprise surprise, the markings are actually a built-in belt stretch monitor. If the arrow on the left moves beyond the two upper marks towards the lone lower mark, the belt has stretched and should be replaced. In my case, the indicator arrow is right at the beginning of the field of travel, indicating no measurable stretch. I removed the belt to examine it – it’s in good smooth condition with no surface cracking. So – no need to change the belt. My new belt can remain in its sealed packaging for future use.

I have since been told that belt stretch indicators are by no means common in modern cars – so full marks to Jaguar in this case!!

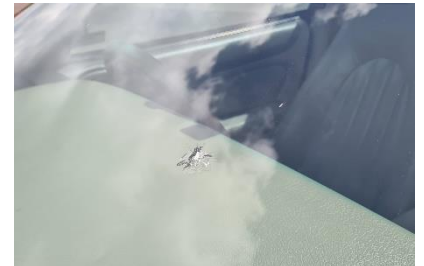
When I bought my car, there was a slight windscreen chip at the top of the screen, above my line-of-sight of the road ahead. Not illegal, but once seen, cannot be unseen! Towards the end of March I was driving to Bunnings (where else?) when I thought I’d make a detour to O’Brien’s Auto Glass to see if they could repair the damage to make it less obvious, even though it hadn’t deteriorated during my ownership. I was no more than about 500 metres away from turning into O’Brien’s when I heard a resounding “CRACKBANG!” and quickly realised I had managed to get in the way of someone’s ejected stone, and had more than just a slight windscreen chip to deal with. I recounted the story to the man on the desk. Did I get sympathy? No! Just a belly laugh...

The good news is that I have full glass cover on all my cars, so there’s no excess to pay on any glass repair. The bad news is that the new chip is too large to repair properly. More good news, there’s one available in Sydney. More bad news, it was no longer available by the time I lodged my claim 2 hours later. My brand-new replacement windscreen is on order from UK, and due to arrive and be installed sometime in August. Thumbs up for Shannons and O’Brien’s.
